Strengthening masonry cross vaults damaged by geometric instability

Strengthening masonry cross vaults damaged by geometric instability.

Keywords: Cross vaults, Gothic, FRP, abutment spread, Holyrood, rubble masonry.

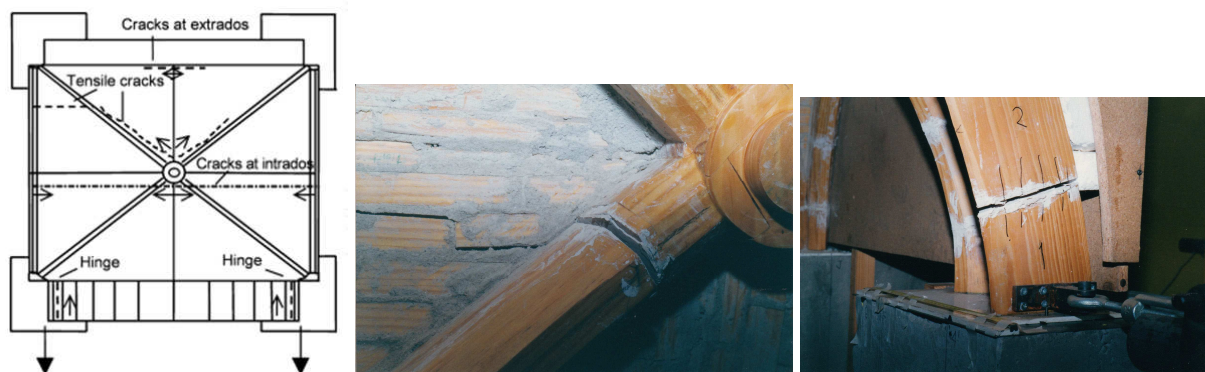
Figure 1. Crack pattern in a quarter-scale model of Holyrood Abbey church [2, 3]

under service loads (dead load) and then brought to failure by lateral support movement [2, 3]. Those tests (Fig. 1) established a pattern that is known in practice and has been summarised qualitatively by J. Heyman [4]: the vault became unstable as a crack appeared at the intrados across the front of the longitudinal vertex, a hinge formed at the base of the nave arch and the back web detached along the back ribs and partially from the wall.

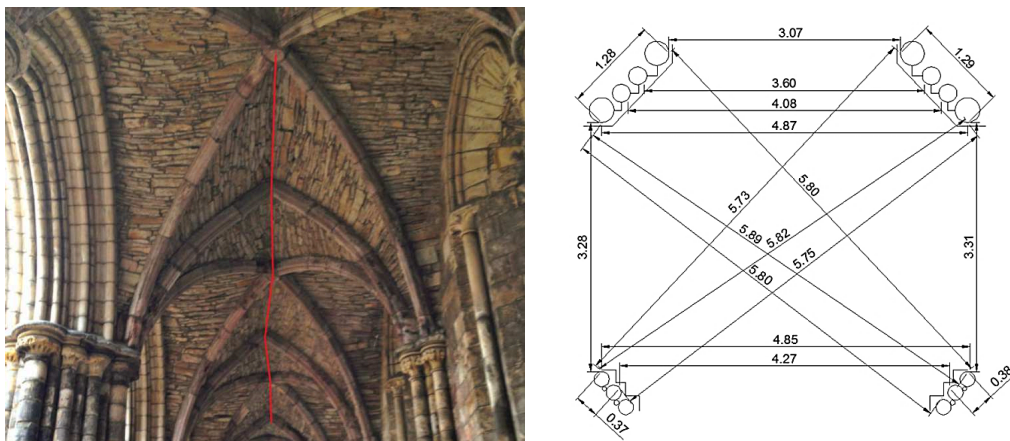
Figure 2. Irregular layout and masonry in Holyrood [17]

It is not certain how far these irregularities have affected the collapse, which may have been accelerated by insufficiently maintained flying buttresses and a probably not very well executed design of sexpartite vaults that was believed to roof the nave. The asymmetry of form and stiffness may have played a bigger role, when combined with insufficient constraints, as the case of equally deformed vaults that are contained by stiff piers and envelope shows (Blyth Priory, Selby Abbey).

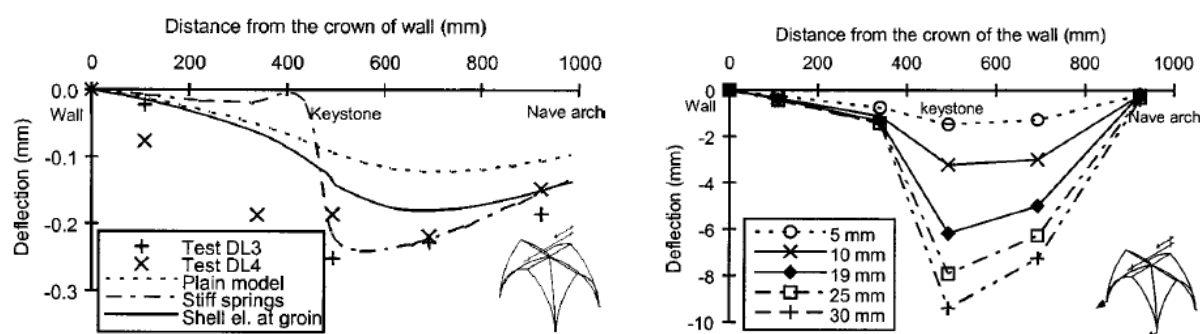
Figure 3. Deflection of the transverse ridge of a model vault from Holyrood Abbey under dead load (including FE analysis) and supports spread [2, 3]

The deformation of the main transverse vertex (Fig. 3), at both stages of the tests, showed a prominence of the deformation of the front portion, beyond the keystone. The stiffness of the nave arch becomes more significant in the support-spread tests: it reduces deflection in the arch's immediate area but the entire front portion of the vault follows the rotation of the stiff plane the arch creates, causing the excessive deformation and eventually detachment of this area from the rest (Fig. 1). The crack pattern (Fig. 1) is relevant to that of many vaults, and its initial stages often appear in service conditions in aisle vaults (especially the crack on the sides of the longitudinal vertex). Failure occurred at 30mm spread (or 1/32 of the span), in a 3 hinge-line mode, although the vault could be spread further to 90mm till a catastrophic collapse occurred.

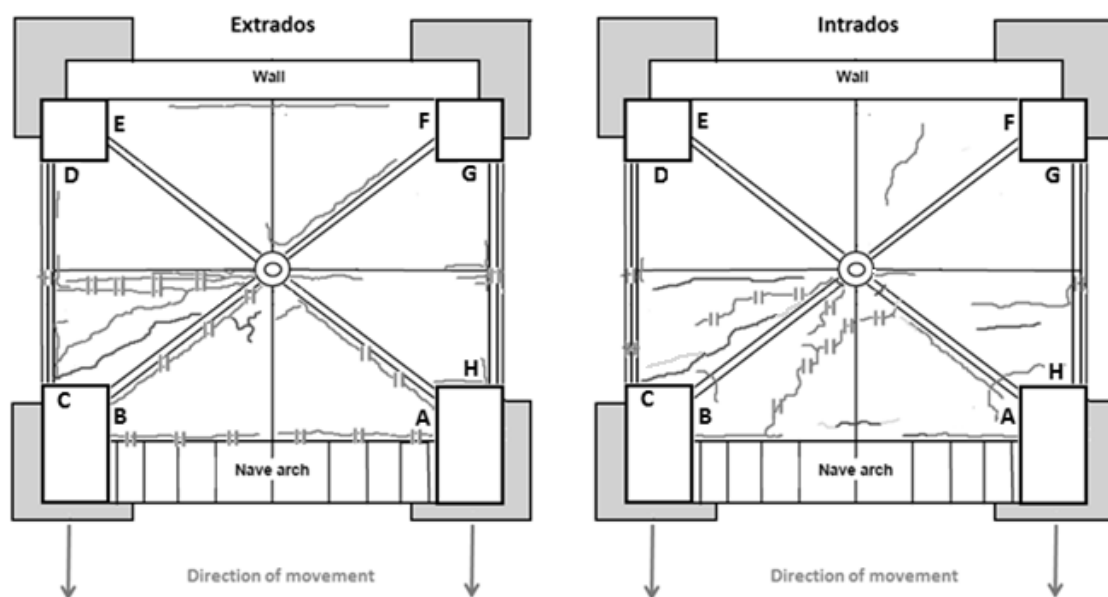
The tests will be discussed at the main stages of supports spread and their repair, and the crack patterns are summarised in Fig. 4. After the first spread of 2 mm, small hairline cracks appeared: on the extrados between the nave arch and webs; along the diagonal rib between the longitudinal ridge and diagonal rib on the front left hand side; and just in front of the longitudinal ridge on the left hand side. The cracks between nave arch and webs were also visible on the intrados, but otherwise no new intrados cracks had appeared. At a spread of 4 mm, a significant transverse crack opened up between the longitudinal ridge and diagonal rib on the front left hand side, extending downwards roughly parallel to the diagonal rib. By the time the supports had been spread to 6 mm, this crack had expanded further, whilst the lower portion of the web had dropped by 2 mm. It is notable that the crack appeared to have originated from where two continuous (aligned) vertical joints. It was decided that in order to avoid premature failure of the vault, these cracks should be repaired at the intrados with FRP and epoxy before spreading the front supports any further.

Figure 4. Location of cracks on extrados and intrados and repairs [17]

Following the repair work, further spreading was carried out, initially to 8 mm. A crack opened up at the intrados towards the back of the vault, and the top of the back wall of the vault also began to separate from the web at the extrados (Fig. 4). A short crack also appeared at the intrados near the keystone at the front of the vault. After 10 mm, this intrados crack had propagated to the nave arch, and other pre-existing cracks near the keystone had become more pronounced. However it was noticeable that the repaired crack had not expanded any further, with the FRP apparently proving effective at holding it together. At 15 mm spread, the nave arch became almost completely detached from the web at the extrados, and a new extrados crack appeared along the diagonal rib at the back of the model. Several smaller cracks also appeared, mostly around the ribs and ridges.

Following the appearance of cracks, repairs were carried out to both the intrados and extrados using FRP bonded with epoxy. The repair materials were applied in four stages. First, in order to prepare the rough surface of the webs, fill cracks, and provide a level surface, an epoxy 'putty' was applied to the repair zones; the putty was made by mixing epoxy with sawdust in order to increase the stiffness. Once this had cured, a layer of epoxy was applied, followed by the FRP fabric, and finally a saturation layer of epoxy. The FRP fabric chosen was a lightweight, flat-braid aramid FRP, with a 45° width of 32 mm. Apart from its lightness (300 g/m²), its flexibility also enables high conformity to the uneven shape of the vault without buckling the fibres. The epoxy used was made up of an epoxy laminating resin, a slow hardening agent, and fumed silica thixotropic powder. The low viscosity of this epoxy allows the FRP to be fully wetted with a low likelihood of air pockets creating bubbles, whilst its low weight and high cured strength are also beneficial.

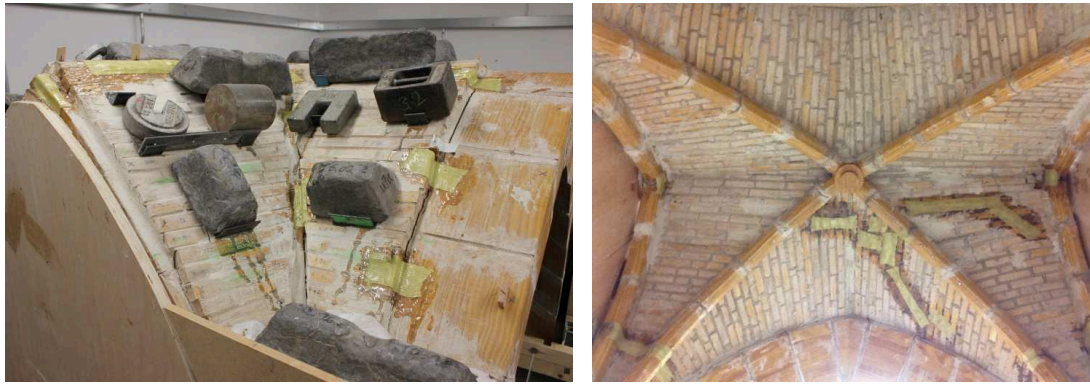
Figure 5. FRP repairs to the extrados and intrados of the vault [17]

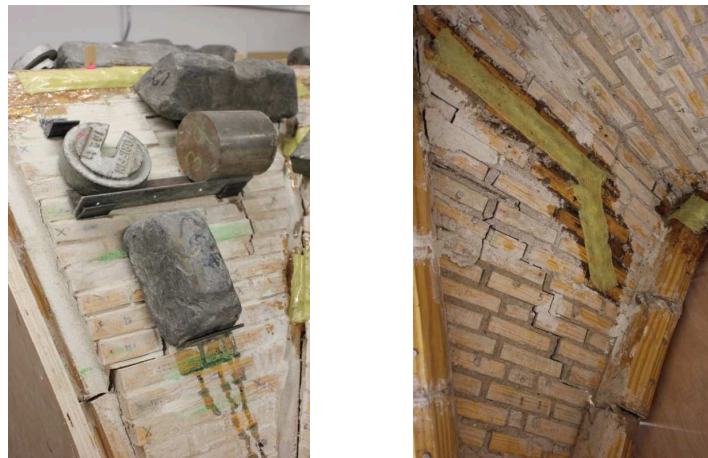
By 6 mm, the other smaller extrados cracks which had opened up after 2 mm had generally extended significantly in length without widening. A crack had also appeared in the intrados just in front of the longitudinal ridge on the right hand side. As can be seen in Fig. 6, the majority of the cracks could be found at the extrados on the front left side of the vault, with several cracks parallel to the longitudinal ridge as well as the large diagonal crack leading into the transverse arch. Cracks had also appeared at the extrados along both diagonal ribs at the front of the model, and at the joint between the nave arch and web at both the extrados and intrados.

Figure 6. New diagonal crack at the front left extrados at 22 mm spread and at intrados

necessary. This was particularly necessary at the joint between the web and nave arch (Fig. 6), which was in danger of complete separation, almost certainly causing collapse. The cracks on the front left were also much larger than those on elsewhere; indeed almost all of the FRP repairs were located in this quadrant of the vault, as elsewhere the cracks were not large enough to require repair.

Following these repairs, at a 22 mm spread a significant new crack appeared parallel to the large diagonal crack, already repaired at 6 mm (Fig. 6). This new crack also protruded right through the web joints, being clearly visible at both the extrados and intrados. Other smaller cracks also appeared at the intrados parallel to the longitudinal ridge. However the repairs carried out at 18 mm again proved effective at preventing any further expansion of these cracks.

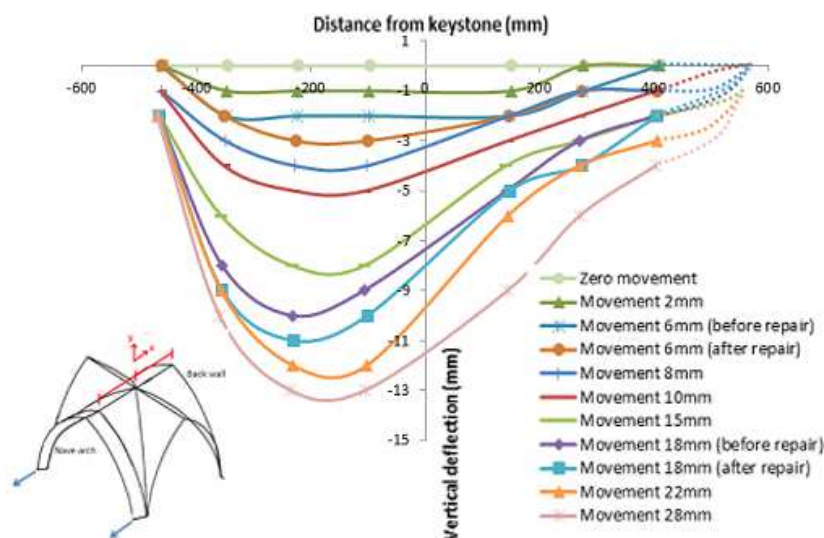
Figure 7. Deflection of the transverse ridge (nave arch on the left, wall on the right) [17]

The deflection of the transverse ridge (Fig. 7) shows a clear trend, with the ridge gradually deflecting downwards as the front supports are spread. The front half of the ridge has the greatest deflections (up to 13 mm at points 111 and 112), with the ridge gradually sloping downwards from the back wall towards the front. Comparison with the previous test (Fig. 3) shows the deflection is higher (max 10mm at 30mm spread), which is expected from the lower stiffness due to the workmanship of the fabric in this test.
